PERFORMANCE OF STEEL STORAGE RACKS IN THE DARFIELD EARTHQUAKE

SUMMARY

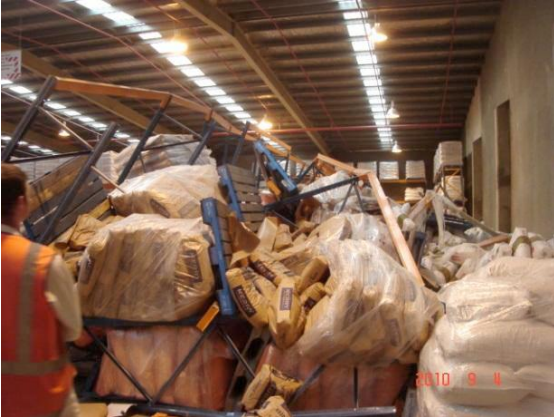
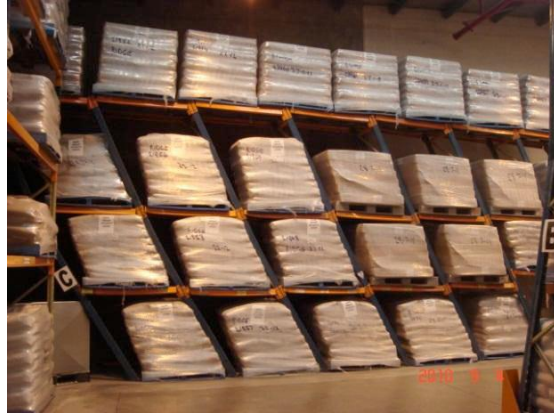
No.1 Single deep selective racking.

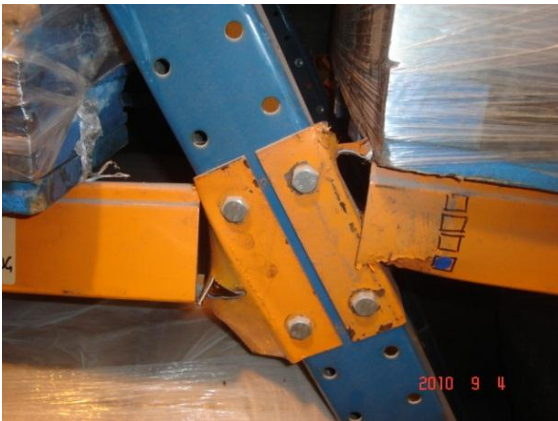
No.1 Beam/column joint in above.

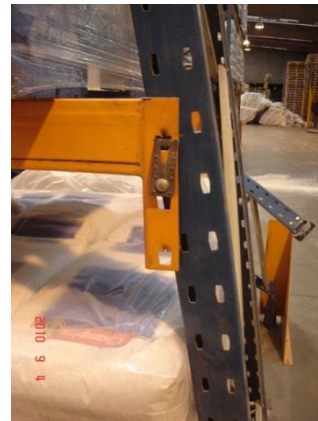
No.1 Clip beam/column joint in above.

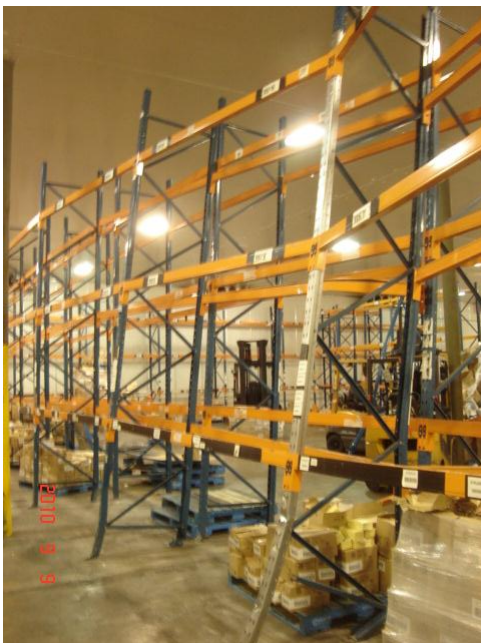
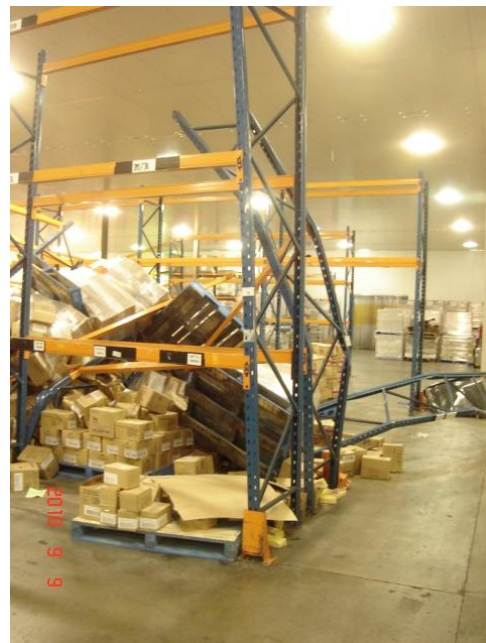
No.3 Single deep selective racking.

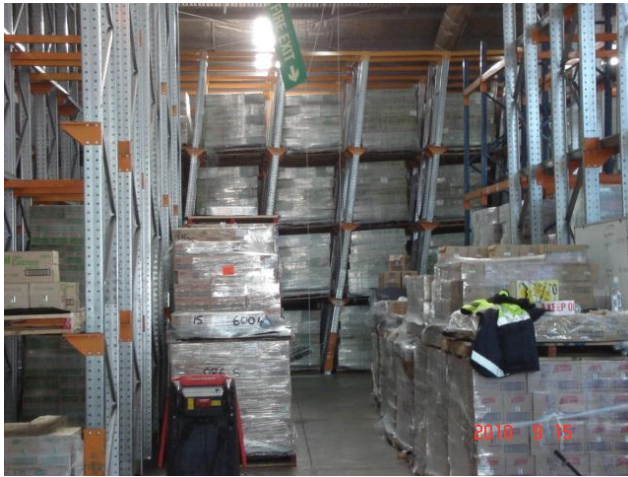
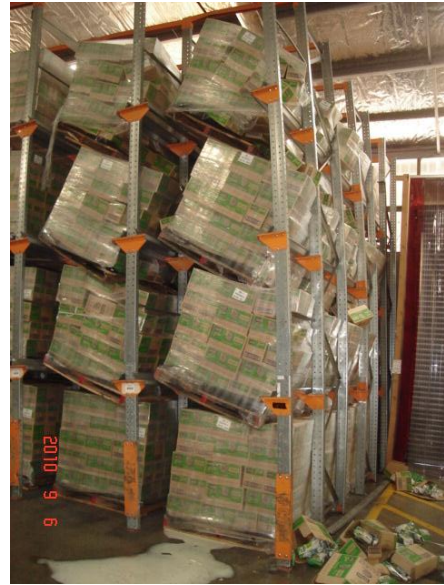
No.4 Drive-in racking.

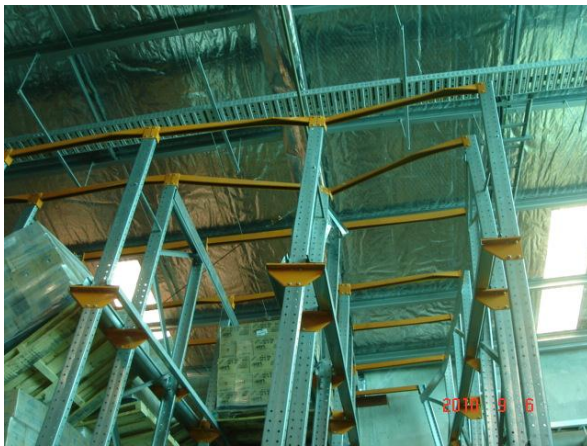
No.4 Eccentric & inadequate X bracing to drive in racking.

- Incomplete load paths existed in some racking installations, where load paths for horizontal cable

cross bracing in the top plane of the racking to vertical column pair bracing were not continuous and relied on bending in cold rolled column sections. The buckling failure of sections under bending appears to have led to sway failure and collapse of racking blocks.

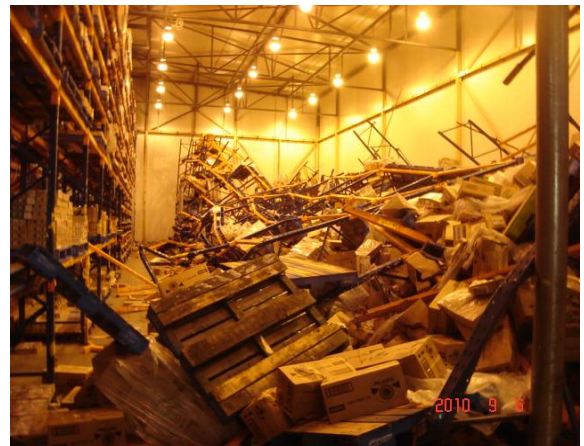
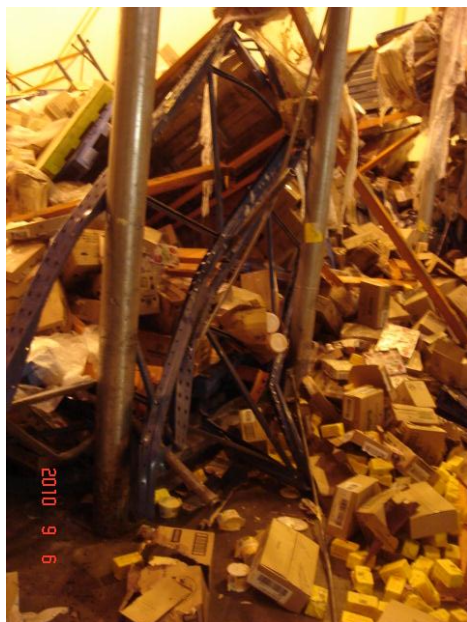
No.5 Single deep selective racking.

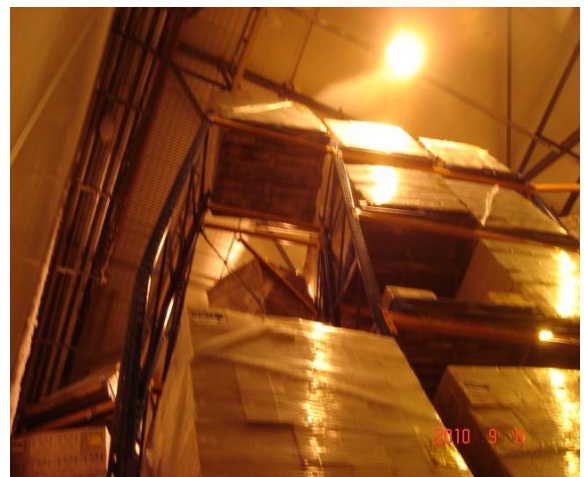
No.5 Single deep selective racking columns.

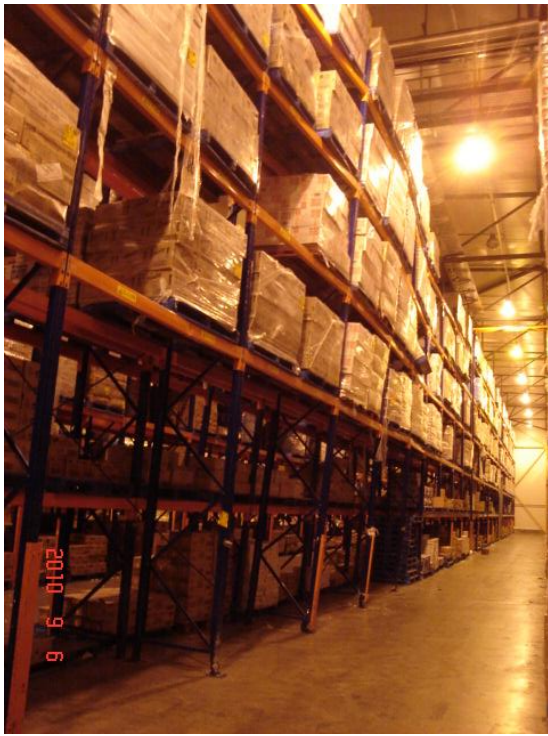
No.8 *Single deep selective racking.*

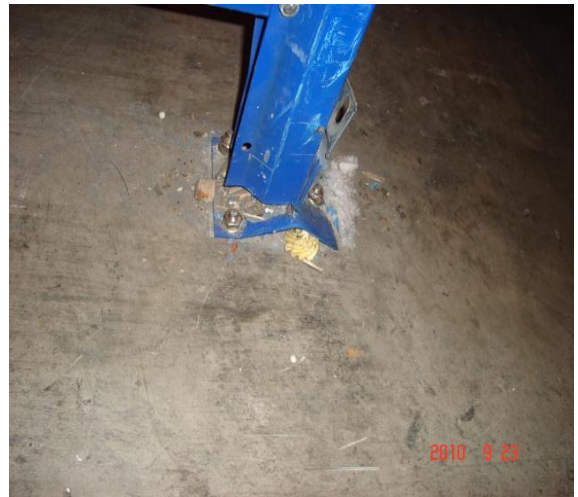
No.8 *Baseplate yielding to racking columns.*

- The damaged and collapsed racking was in a variety of orientations – there was no clear predominant direction to the collapse.
- Detailed investigation of installation No.8 selective racking indicated no capacity design measures were used for baseplates – cold rolled column section welding to the baseplate was not continuous so local buckling occurred with and without baseplate bending.

- If baseplate yielding is designed for, capacity design must be applied to the cold rolled columns and bracing connected to the baseplate. It did not appear this approach had been taken on any of the racking inspected by the author after the earthquake. With the thin 3 mm to 6 mm baseplates in the racking inspected, it is unlikely the baseplate yielding will produce sufficient energy absorption to be able to achieve any significant ductility. Thicker baseplates, at least 10 mm or more, are likely to be required, with associated over-strength problems connecting the light cold rolled column sections to these baseplates.

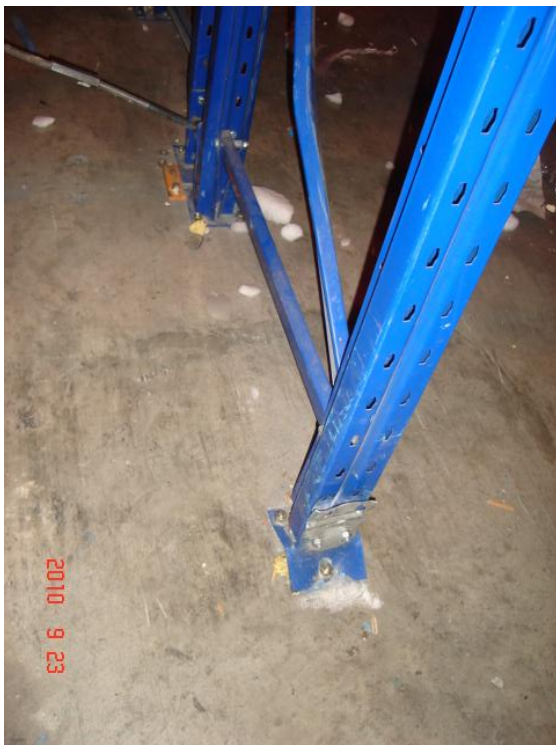
No.8 *Baseplate & brace yielding to columns.*

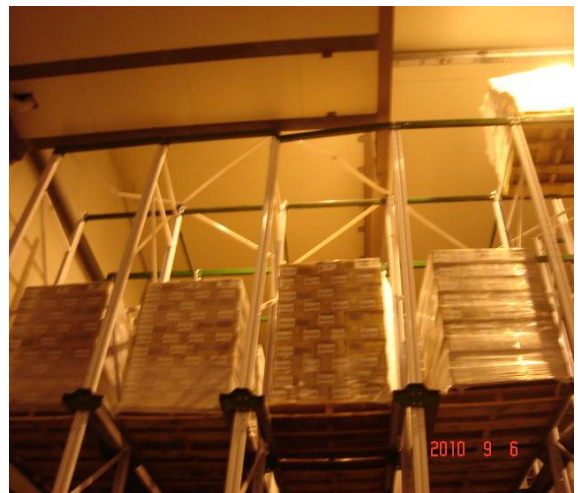
No.9 *Distorted bracing to drive-in racking.*

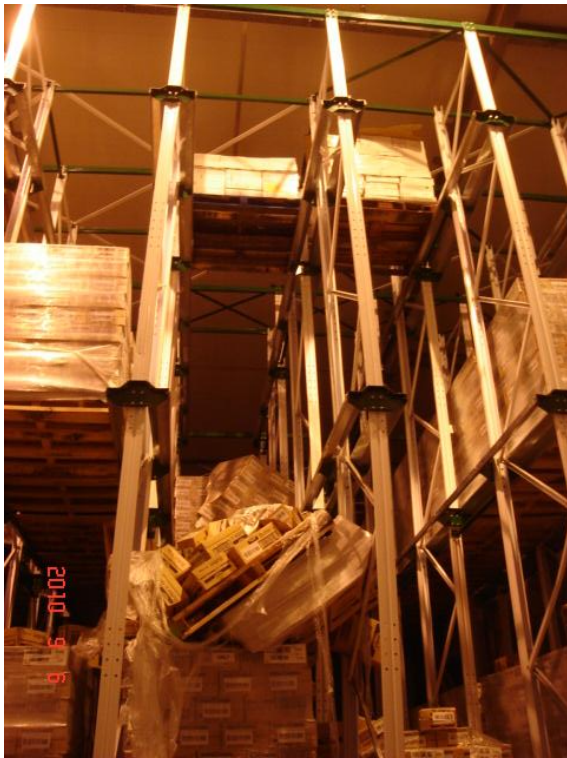
No.9 Deflected columns to drive-in racking.

- In drive in racking which was not fully loaded, columns deflected laterally, allowing pallets to drop down between the support rails.
- In fully loaded drive-in racking there was widespread failure laterally, apparently due to excessive deflection and P-delta effects as described above.

- Racking columns must be designed with sufficient lateral stiffness between support points to retain the product under earthquake loading, particularly drive-in racking with high laterally unrestrained columns.

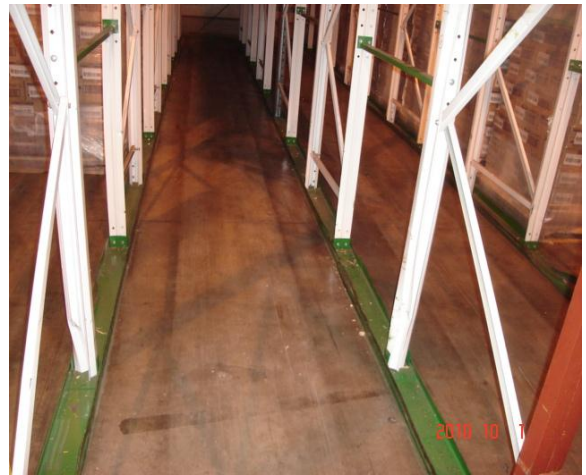
No.9 Forklift damaged columns.

- Racking should be designed with protection against forklift damage (*all racking manufacturers have standard protection components*) and racking should be inspected regularly to identify damaged racking components, and these replaced with new.

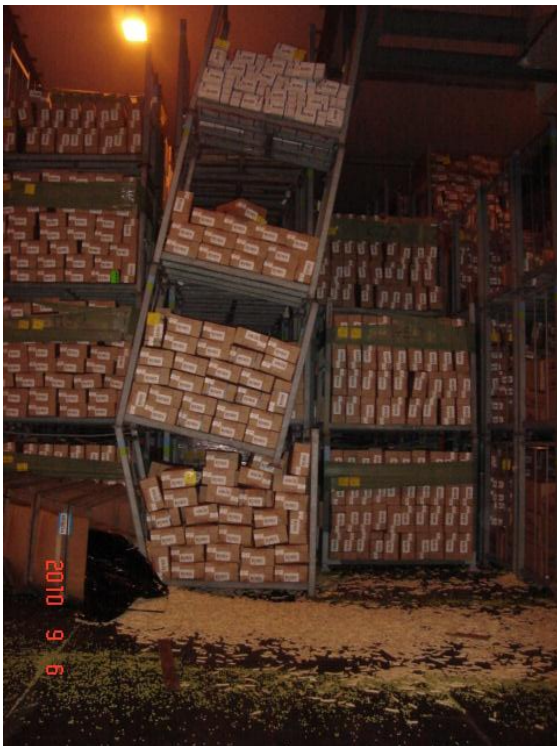
No.11 Distorted post pallets.

- The one post pallet installation had no holding down fixings, and appeared to fail from both uplift of upper pallets from the lower, and lateral sway deflection of the pallet uprights. Post pallets were initially designed in the early 1970s and have traditionally been limited to three pallet high stacking. The author's subsequent checking of similar post pallets for a temporary post-earthquake installation confirmed the requirement for holding-down fixing for stability, and the potential instability of post pallets when stacked more than three high.

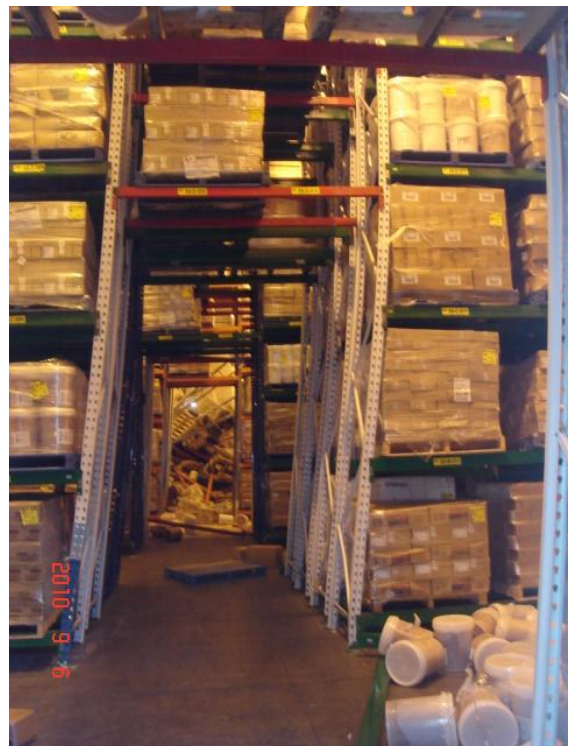
No.12 Double deep selective racking.

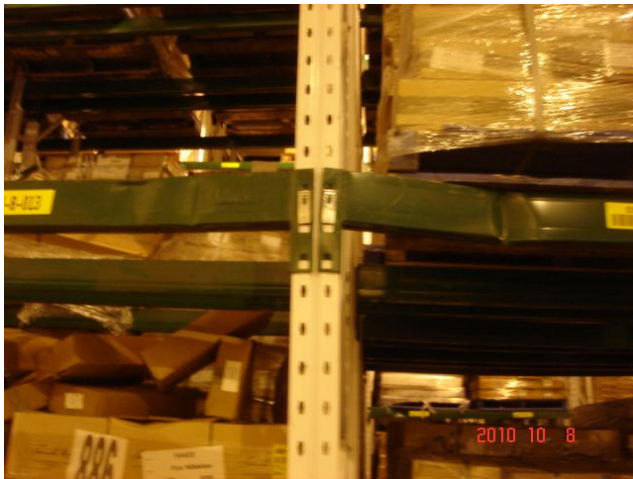
No.12 Distorted double deep racking beam/column.

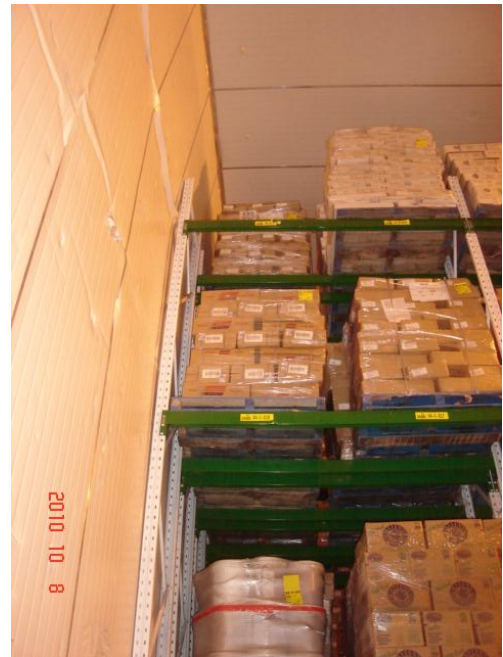
No.12 Wall pounding of double deep selective racking.

- In several cold store racking installations, racking had pounded against cold store walls. This appeared to be due to excessive racking deflection as the building structures generally showed little evidence of lateral movement in the earthquake, and the racks were partially collapsed and in places held up by the cold store walls.
- Damaged racking components appear to have contributed to racking collapses in some cases, though this damage does not appear to have been the primary cause of collapse.
- There was no visible damage to concrete floor slabs in any of the installations, apart from local chipping and impact damage from collapsed racking and product. There were some pull-out failures of expansive fixing bolts from concrete slabs, but no evidence of slab cracking from either uplift or downward loadings.

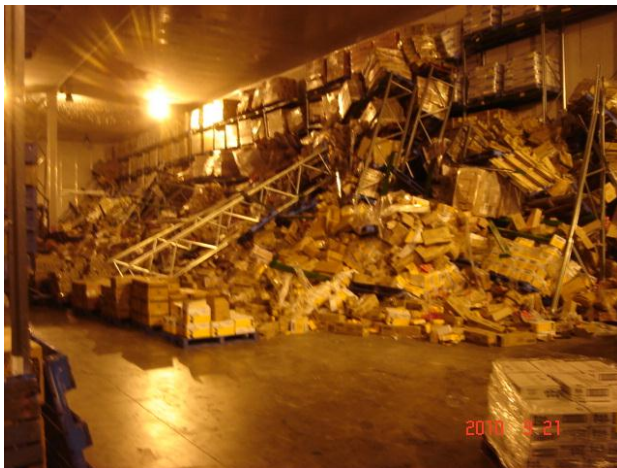
No.13 Single deep selective racking.

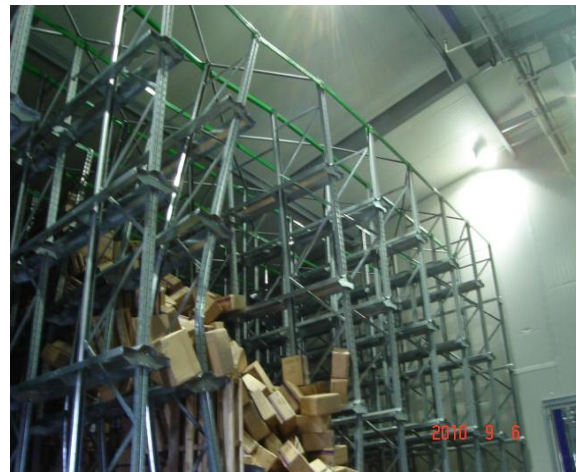
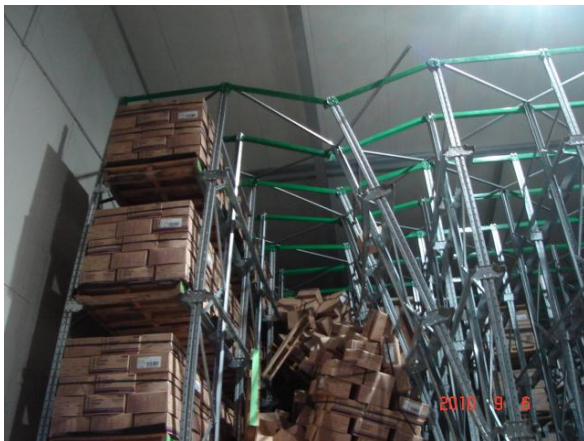
No.16 Deflected columns to drive-in racking.

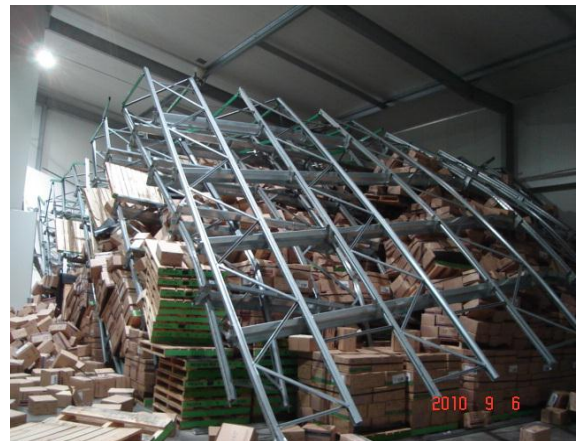
No.16 Collapsed drive-in racking.

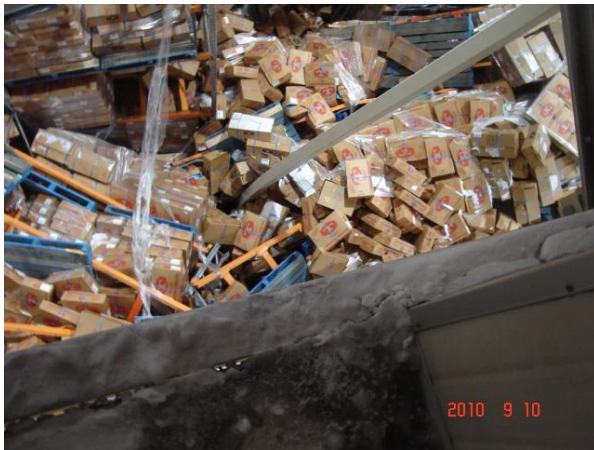
No.17 Collapsed double deep racking.

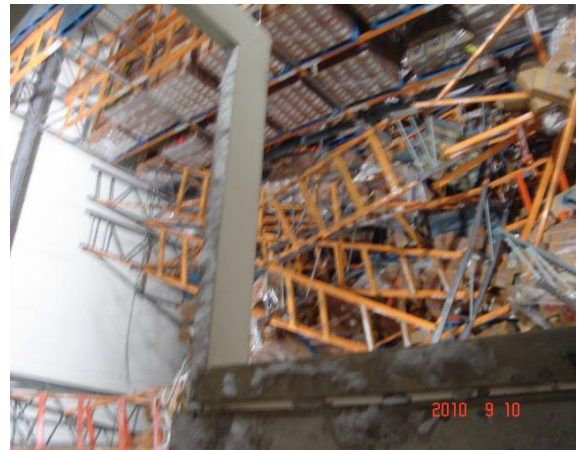
No.17 Collapsed drive-in racking.

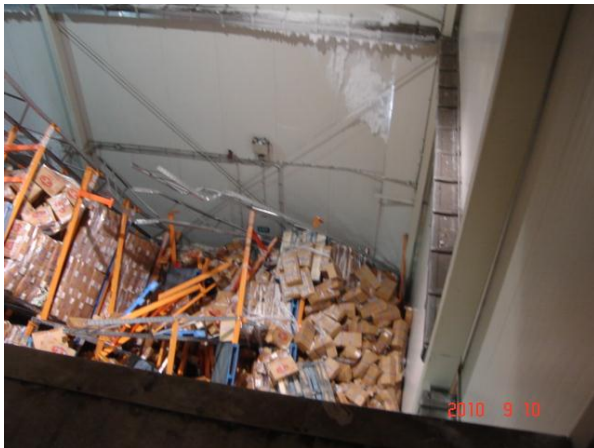
No.17 Wall pounding from collapsed racking.

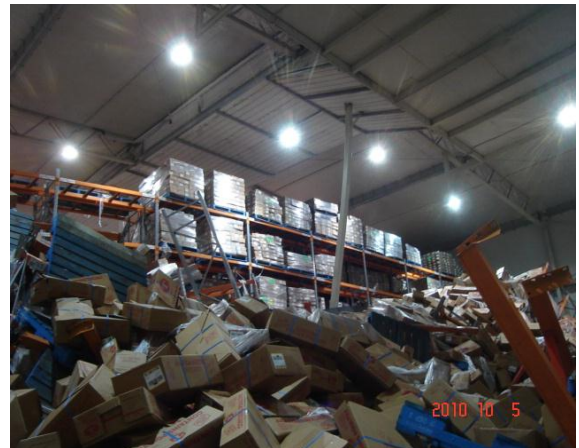
No.17 Roof prop impact from collapsed racking.
